# RESILIENT BUILDINGS

## Warner Community Center 49 W. Main St, Warner

### Level II Energy Audit

December 16, 2022

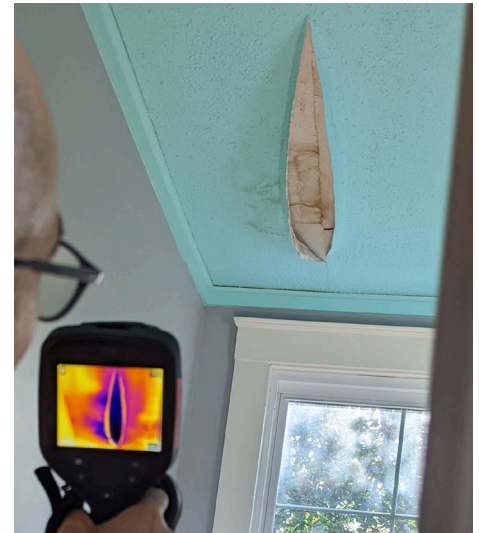
Photo 1. Signs of possible roof leak

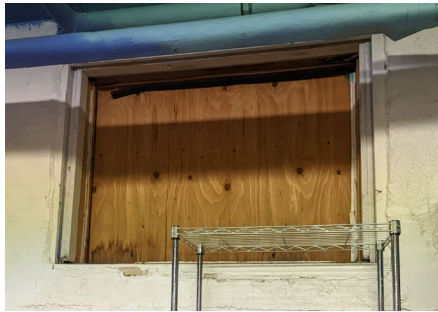
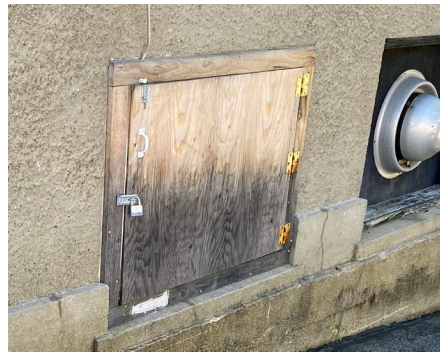
Photo 2. Uninsulated, leaky loading window

- **B1. Air seal:** The most important component of any energy efficiency retrofit is controlling or slowing down the migration of air from conditioned to unconditioned spaces. To reduce this uncontrolled air exchange, the following measures should be implemented before any insulation is installed. Although a blower door test was not performed, a visual inspection determined the following recommended air sealing efforts.
  - The loading window in the pantry on the lower level is blocked by a piece of plywood. If this access is required, RBG recommend constructing an insulated panel with a durable gasket and latching mechanism be installed.

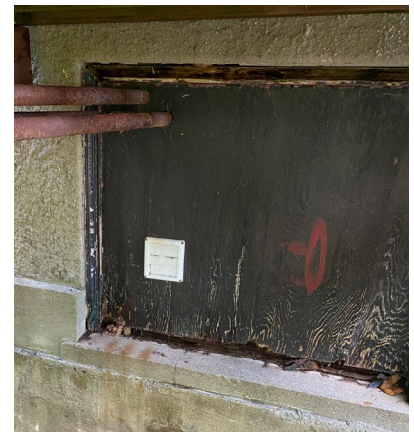
Photo 3. Plywood panel needing air sealing

- The front doors are scheduled to be replaced. RBG concurs with this measure. Daylight is visible around the door and the plexi-glass is not secure. When replacing the front doors, include the transom windows above doors.
- The plywood panel where the bathroom exhaust fan exits, and the oil fill lines enter appears in need of repair. RBG recommends using pressure treated plywood and sealing the perimeter of the panel and the oil fill line penetrations.
- Install a gasket around the attic access or caulk the access closed.
- The rear door roof access in the thrift store should be weather-stripped.

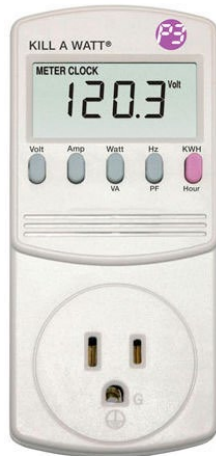
Photo 4. Affordable, easy to use meter to measure freezer electric consumption

The food bank is considering replacing the chest and upright freezers with a single, walk-in freezer. A single, walk-in freezer could be logistically more efficient. However, the electric consumption might be greater than the existing freezers combined. We recommend metering the appliances for a week to determine their actual consumption and then searching for Energy Star walk-in freezers here:

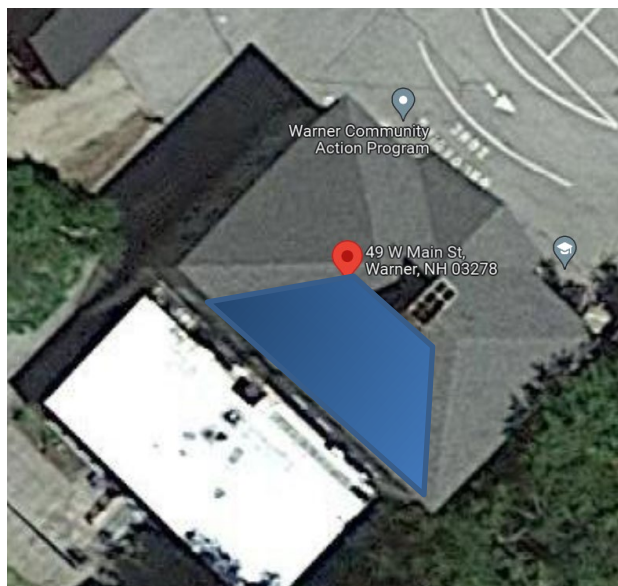
Photo 5. Proposed solar PV

- **R1. Solar PV:** Solar PV could be an excellent option for the Community Center building if the heating system is converted to electric air source heat pumps. However, additional analysis may be needed to determine if the roof can handle the added weight load and whether the adjacent trees shade the panels too much.

If these concerns are addressed, RBG proposes a 13.7 kW PV Array. This array is projected to generate 16,818 kWh/year assuming the installation of high-efficiency panels and limited shading. The building's electric consumption averages 17,847 kWh per year. This means the proposed PV system would generate 94% of the building's average annual electric usage. If the Community Center plans to electrify the HVAC systems, RBG recommends installing addition panels on the west facing roof to account for that additional consumption.
