Warner Community Center

49 W. Main St, Warner

Level II Energy Audit

December 16, 2022

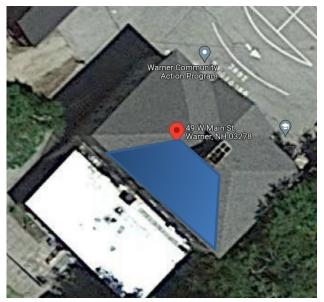
Photo 5. Proposed solar PV

• **R1. Solar PV:** Solar PV could be an excellent option for the Community Center building if the heating system is converted to electric air source heat pumps. However, additional analysis may be needed to determine if the roof can handle the added weight load and whether the adjacent trees shade the panels too much.

If these concerns are addressed, RBG proposes a 13.7 kW PV Array. This array is projected to generate 16,818 kWh/year assuming the installation of high-efficiency panels and limited shading. The building's electric consumption averages 17,847 kWh per year. This means the proposed PV system would generate 94% of the building's average annual electric usage. If the Community Center plans to electrify the HVAC systems, RBG recommends installing addition panels on the west facing roof to account for that additional consumption.
