# Town Garage

# ANNUAL ENERGY USE SUMMARY

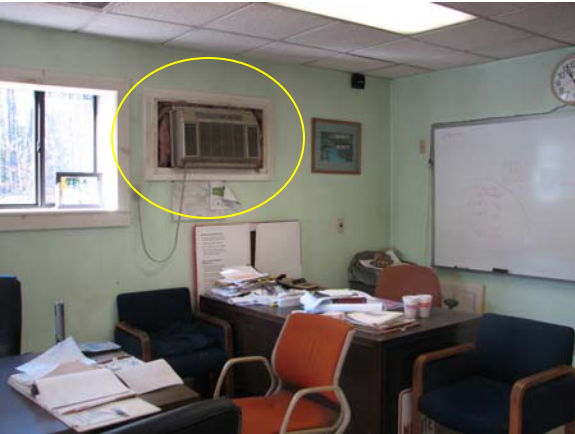
Fiberglass batts behind this thick layer of poly is not an ideal assembly, but very costly to re-do. Several areas have roof leaks, so as the leak is repaired, I recommend removing the damaged fiberglass and using spray foam directly under the metal decking for as large an area as can be afforded. Eventually, a foamed deck – above or below – is recommended.

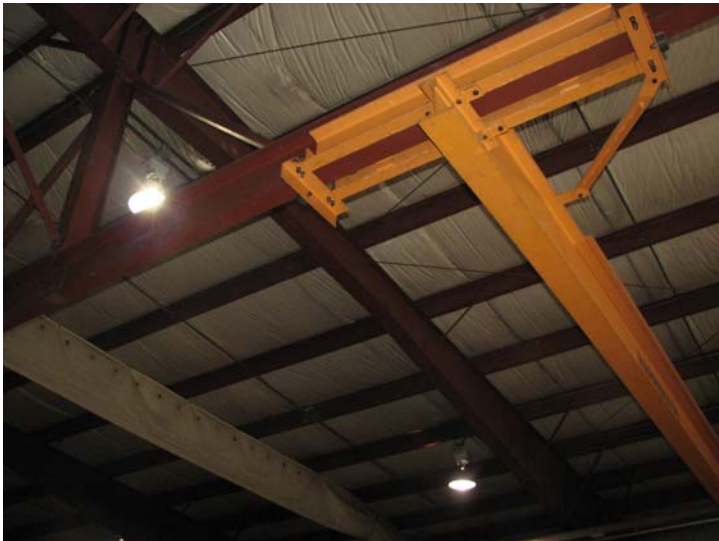
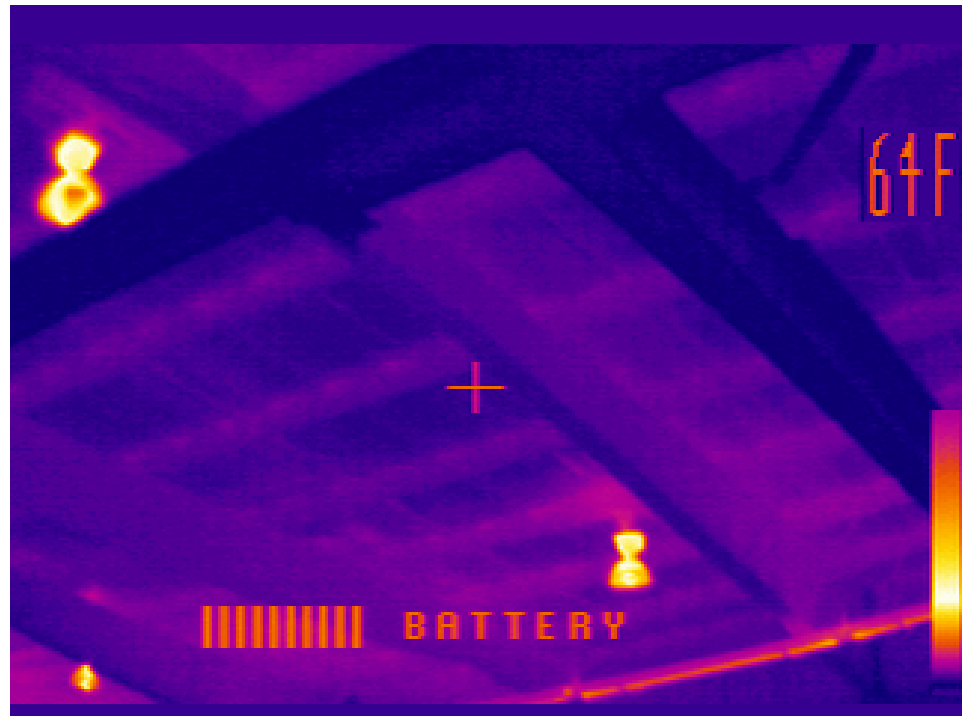
This part of the roof is below the storage space so easily accessible.

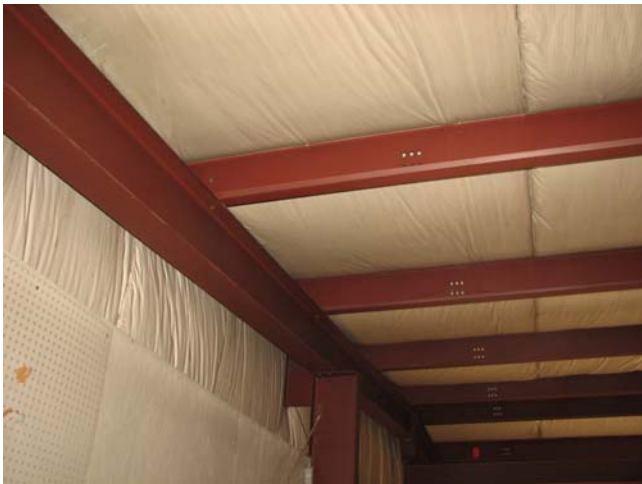
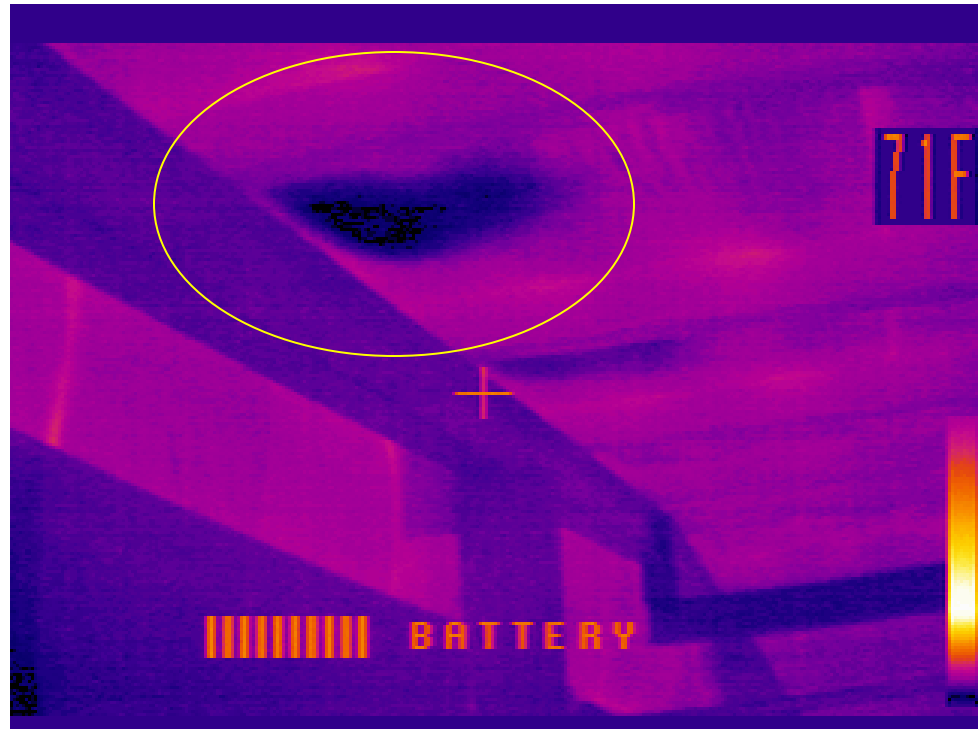
This pattern strongly suggest pooling water – likely from a roof leak.

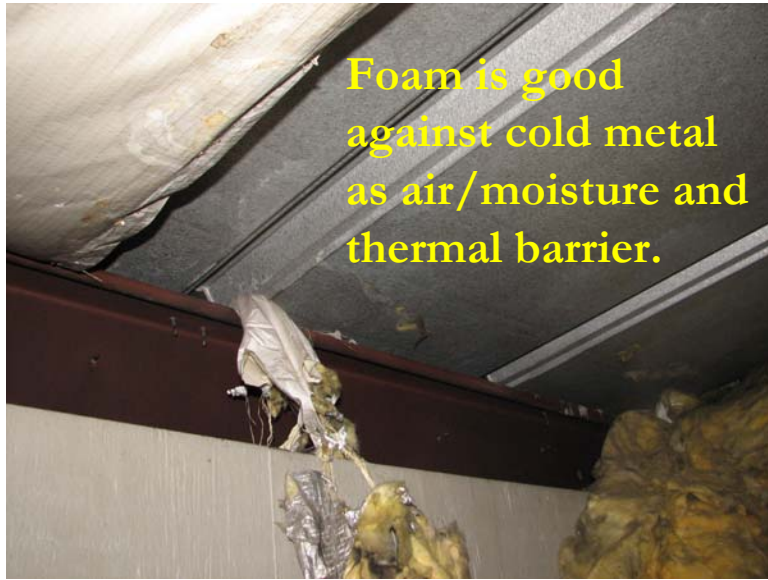
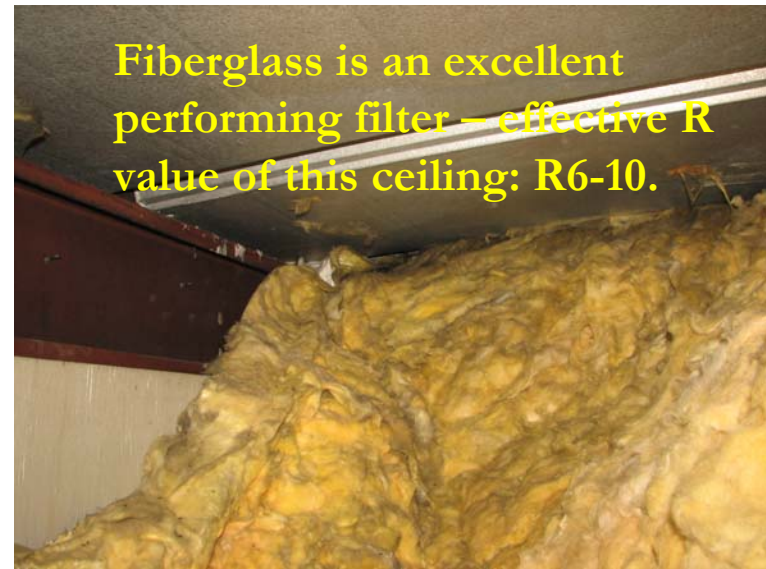
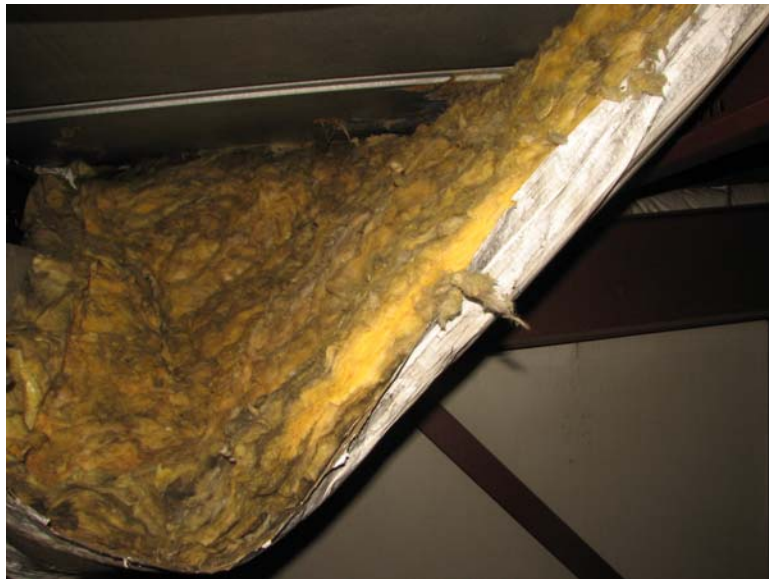
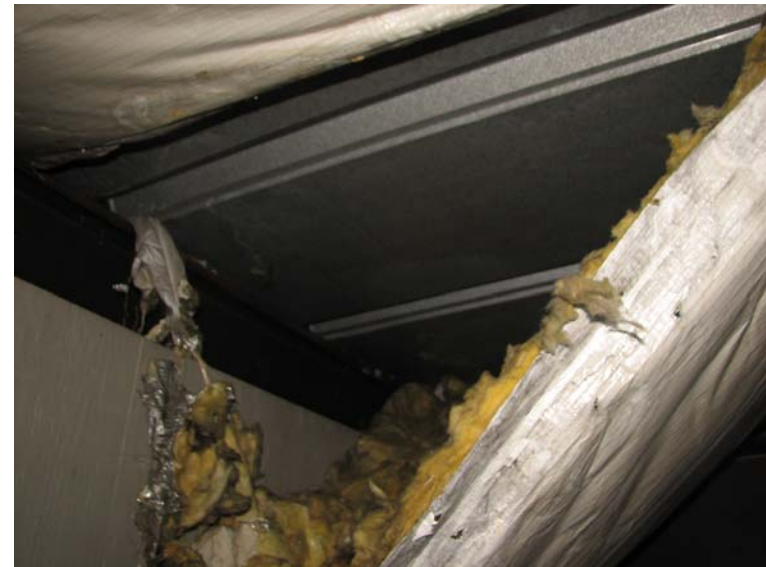
Solatronics' propane fired infra red heat tubes are considered the 2<sup>nd</sup> best / most appropriate heating technology for garage bays and warehouses (radiant floor is #1). Interesting to note that upper areas still warmer, but these units had just come on.

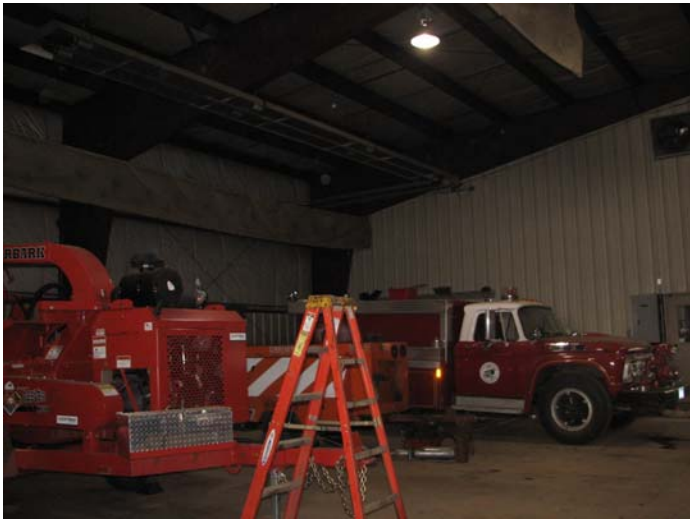
Another large opportunity lies in the uninsulated exposed foundation wall – approximately 1000 square feet at R1.

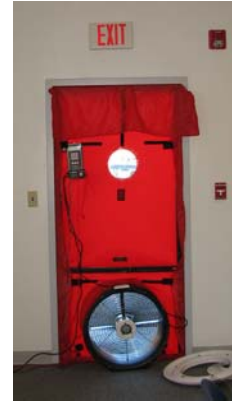
**Whole Building: 11,113FM50**

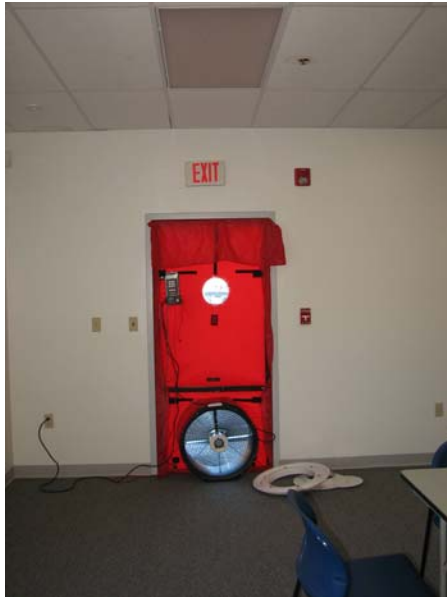
With the building at -19pa, the fan pulled 5800cfm of air through cracks and gaps in the envelope.

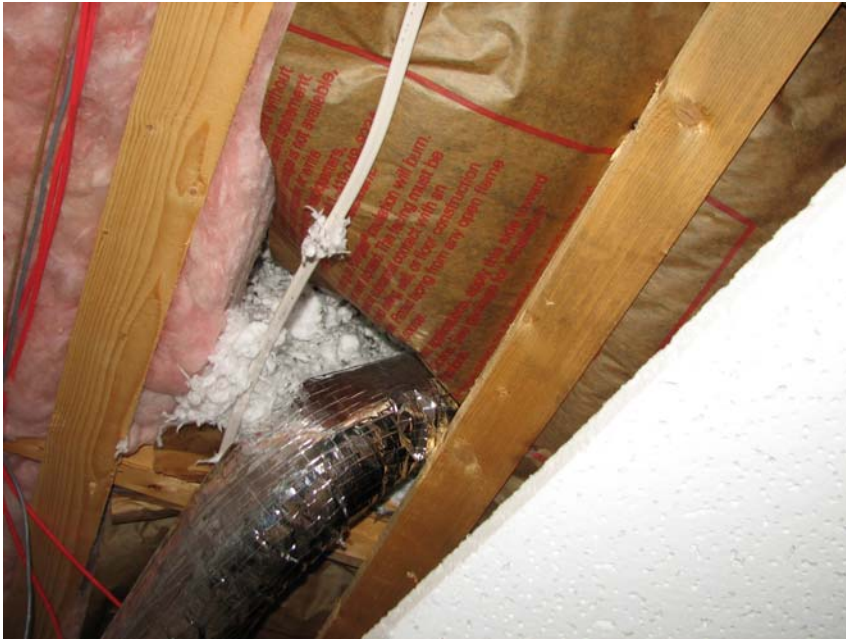
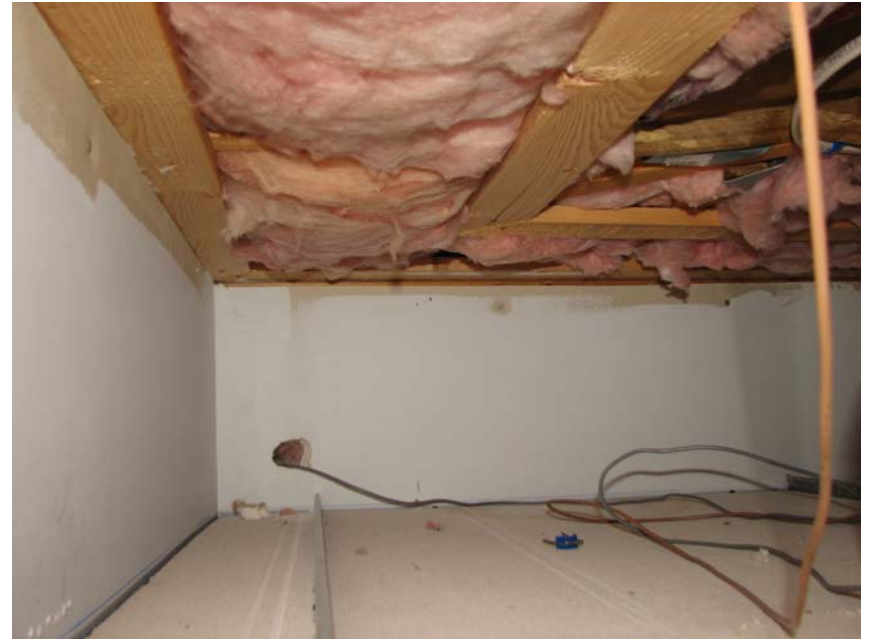
Next would be above the top plates and individual penetrations.  
But, a comprehensive air barrier is the only real solution.

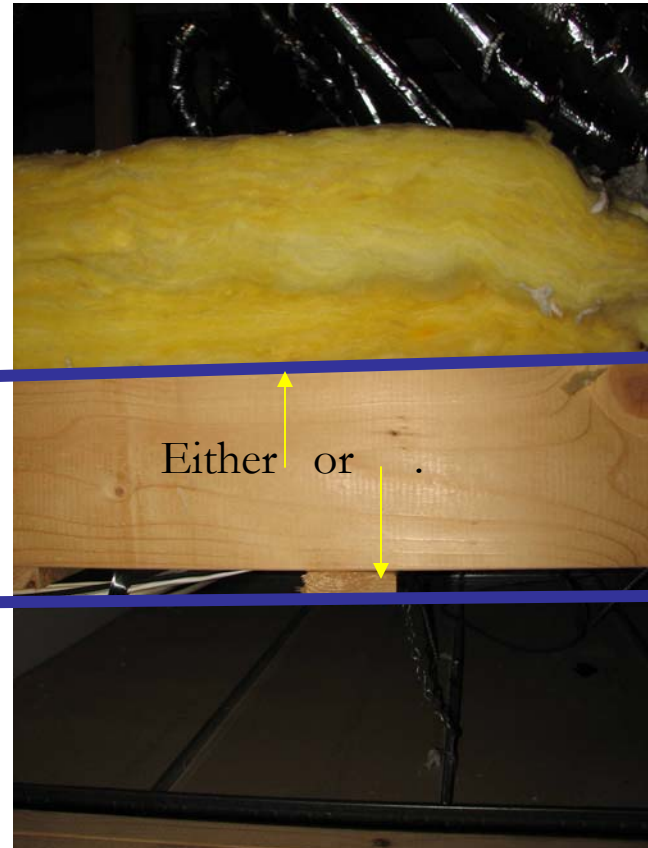
Air barrier location.

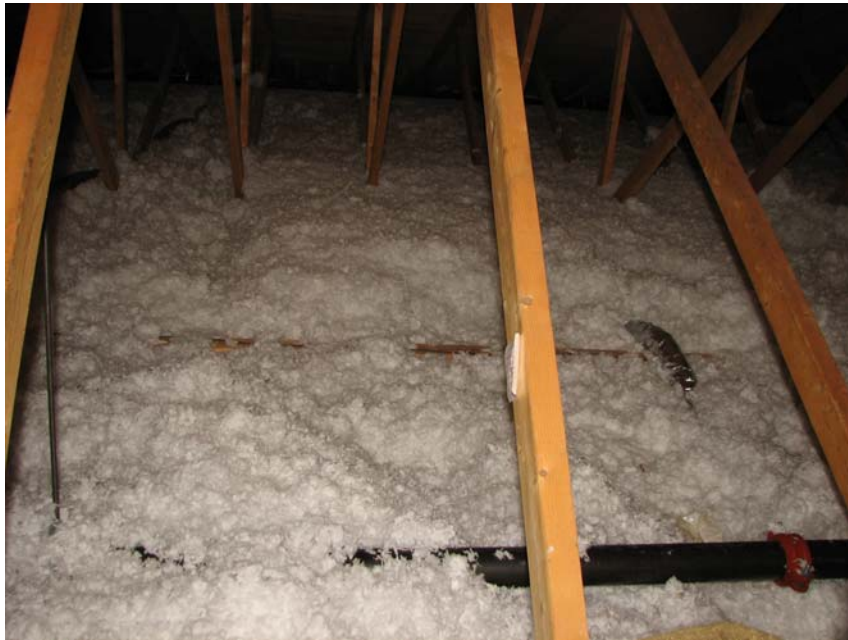
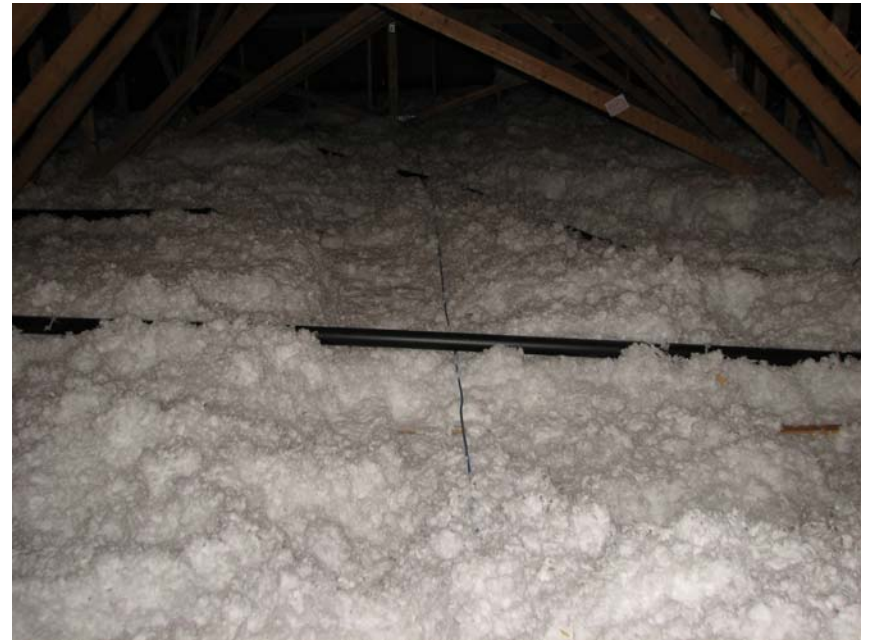
Heating equipment is a Weil McLean Gold CV propane, non condensing, but sealed combustion, boiler rated at 87%AFUE. Unknown whether it is true modulating and connected to outdoor reset, or whether lower water temps are, or can be, used for floor radiant pipes. The boiler is relatively new, appears in good condition and therefore not a good candidate for replacement.

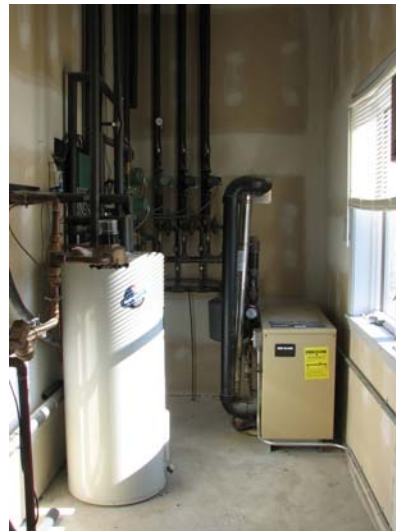
Bradford hot water tank uses preheated water from boiler and appears adequate.

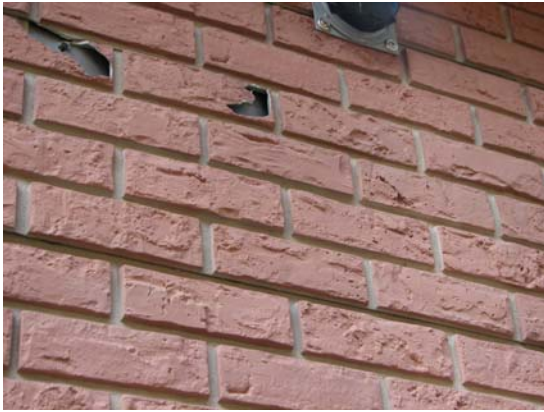
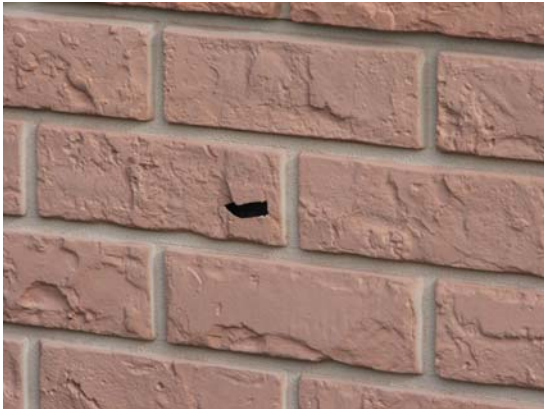
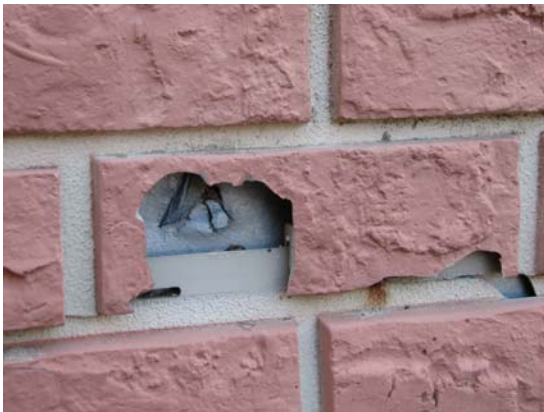
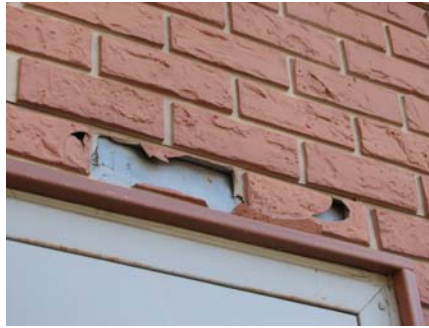
While non invasive techniques used for this assessment did not reveal any moisture issues, it is only a matter of time before these holes breaks in the exterior surface leak water enough to cause damage. When its time to re-side the building, it would be a good opportunity to continue improving the air barrier and reduce thermal bridging. As it appears there is a layer of poly on the interior, between the studs and

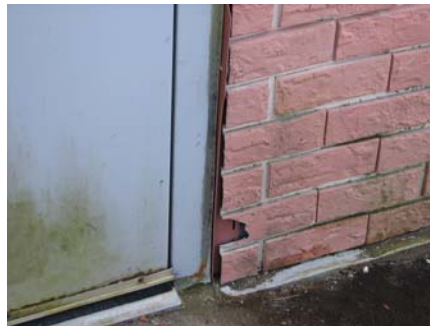
drywall (but this should be confirmed), it is important not to use an impermeable material on the exterior so that moisture may become trapped. Adhering 1 ½ to 2 inches of a semi impermeable rigid foam board, however, would accomplish the energy upgrade. Securing vertical furring into the studs thorough the foam board creates a drainage plane and drying space and gives something to secure siding too.

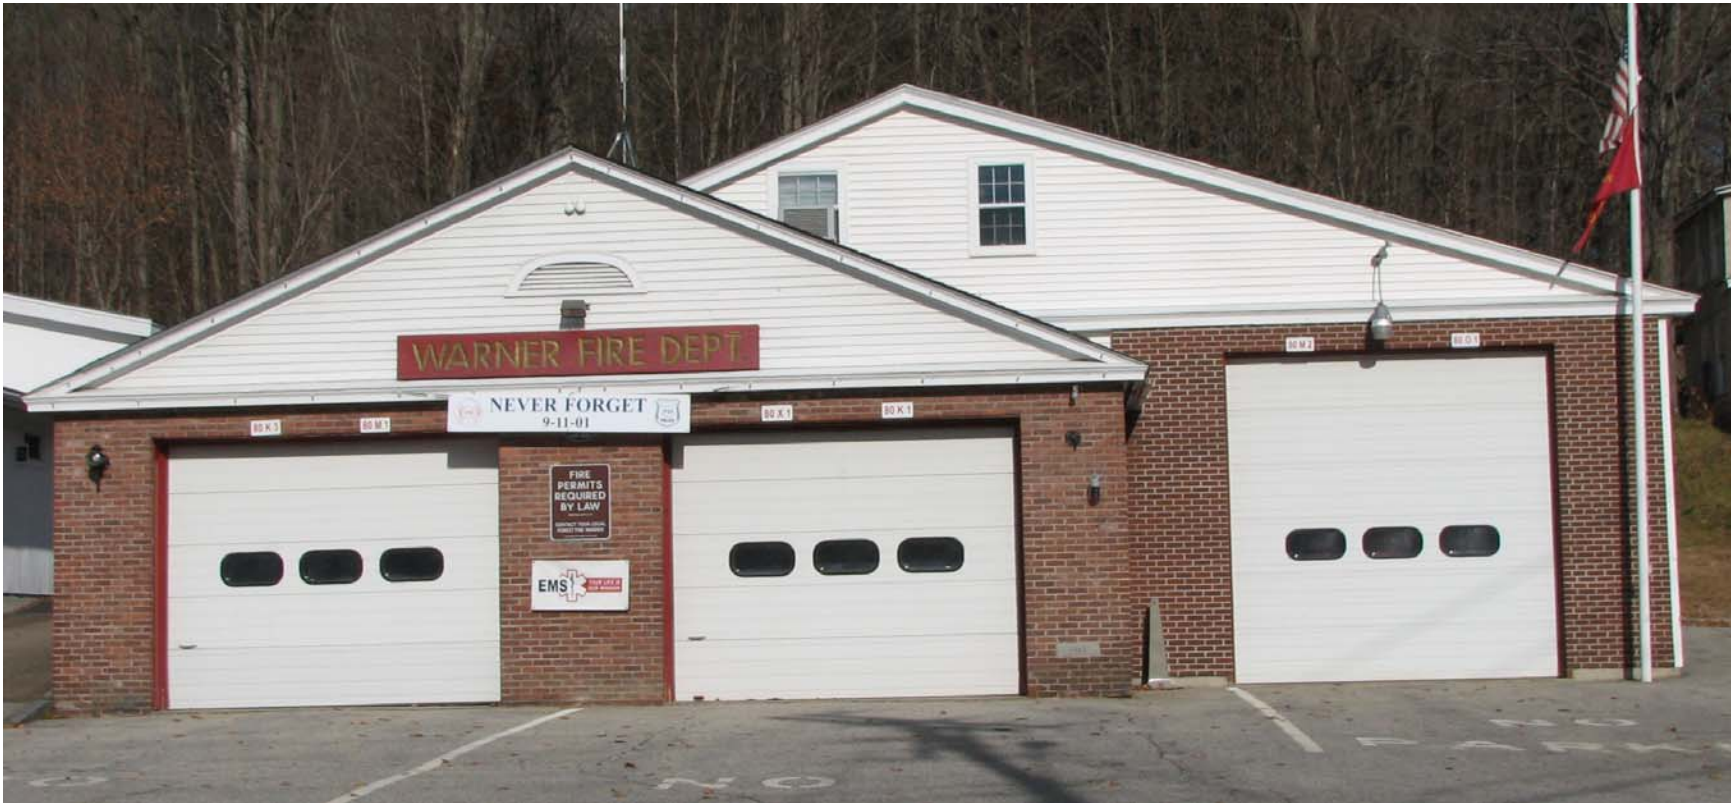
# ANNUAL ENERGY USE SUMMARY

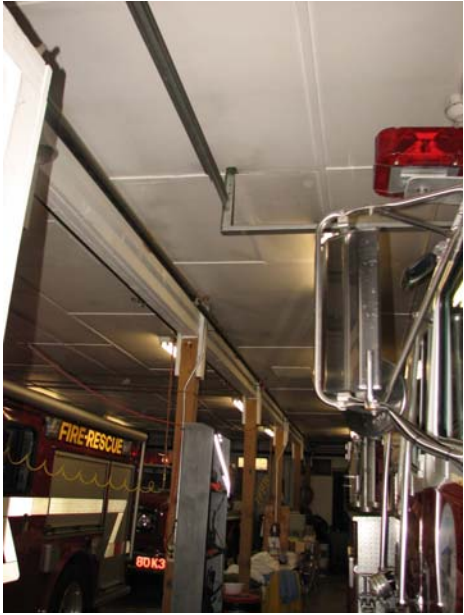
This ceiling is under an outside attic – thermal bridging and minimal insulation are fairly easy upgrade opportunities.

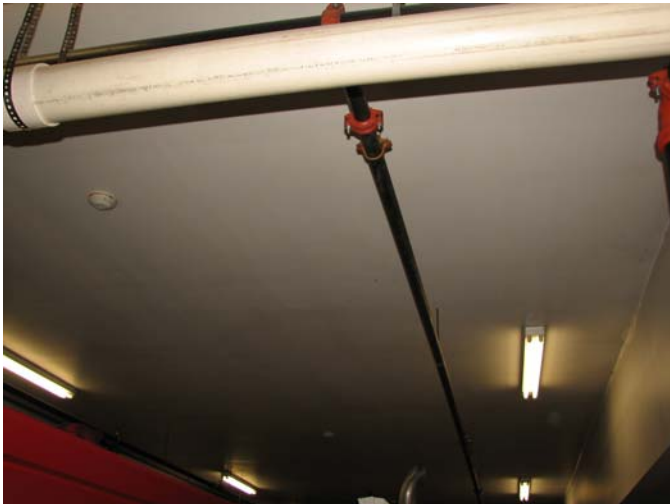
Darkest spots indicate cold outside air from attic washing through insulation – and exfiltration warm air under normal conditions...note the same patterns in the visual images indicating moisture and/or dirt particles.

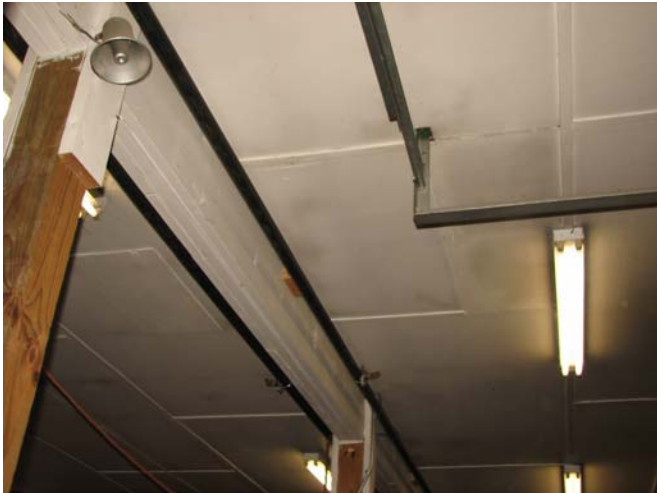
While air infiltration plays a large role in heat loss, the uninsulated concrete block walls have almost twice the heating load which is unusual! Insulating these walls on the outside similarly to prior descriptions would be advised for any energy retrofit and if the building is to remain heated and in use. In addition, adding substantial insulation in the attic would be recommended.

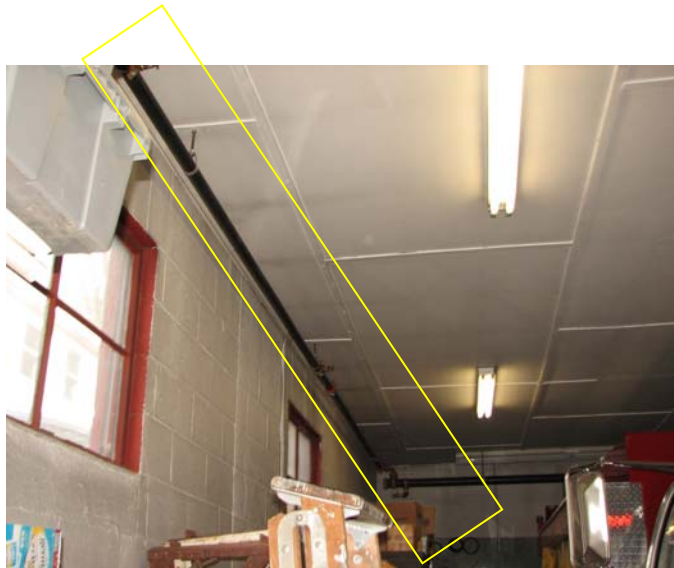
Costs have not been included due to the hope for a new fire station. Costs for R20 walls should be in the neighborhood of \$20,000. Ventilation and exhaust systems will be the far higher expense. If the building is an adequate size however, it appears that it could be upgraded to meet air quality code issues as well as very low energy bills.

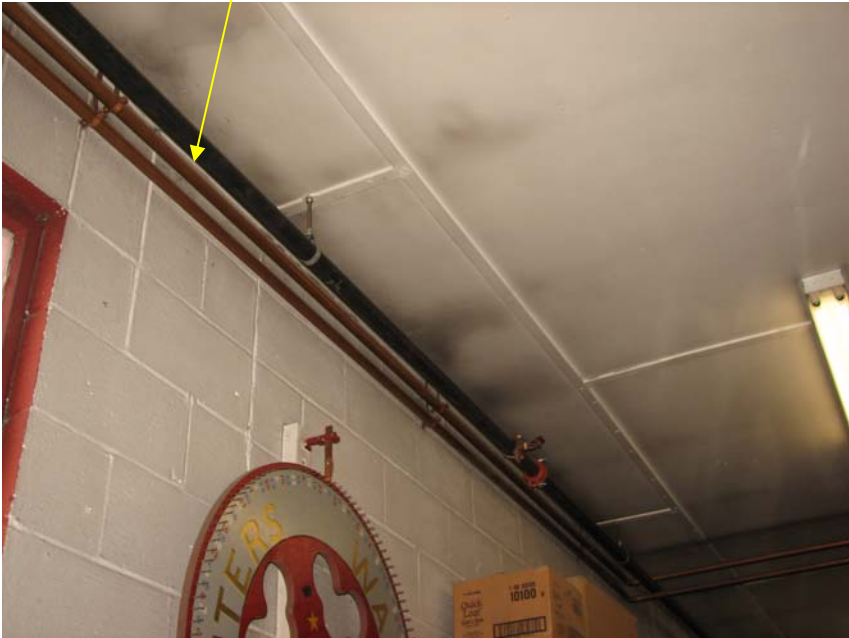
Extensive air sealing is recommended throughout the ceiling plane in the two attic areas and at the perimeter of the room. For optimal performance, removing fiberglass, air sealing and adding 15" blown cellulose and dense pack in the vertical walls then 2" foil faced polyiso, as with other buildings, is recommended. However, this building is unique because of its limited and sporadic use and relatively low thermostat settings during those times means that relative fuel consumption is lower. Also, more importantly, there is talk of a building a new fire station.

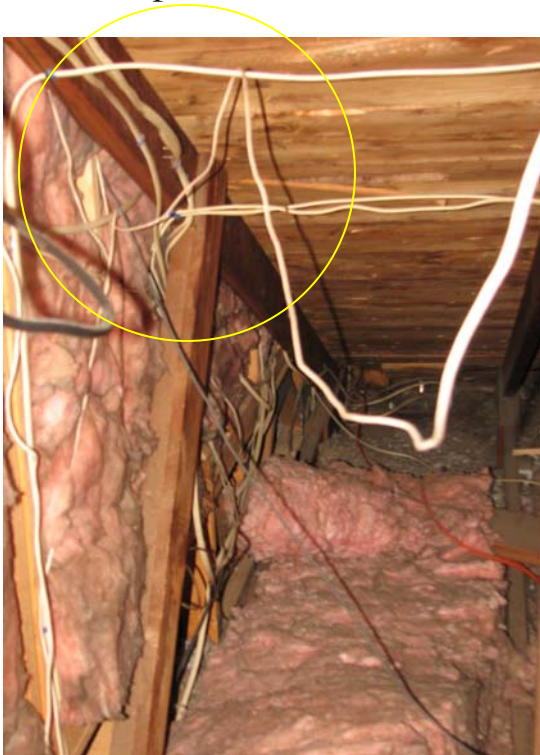
Therefore, for the present planning purposes, thorough air sealing is all that is recommended. IF, plans for a new building are delayed for more than a year or two, then more extensive insulation upgrades would be advised: in the attic, meeting room walls and ceiling, and even more – a minimum 3” rigid foam on the exterior of the block walls. There are a number of products which include metal or other siding which would be appropriate for a fire station wall.

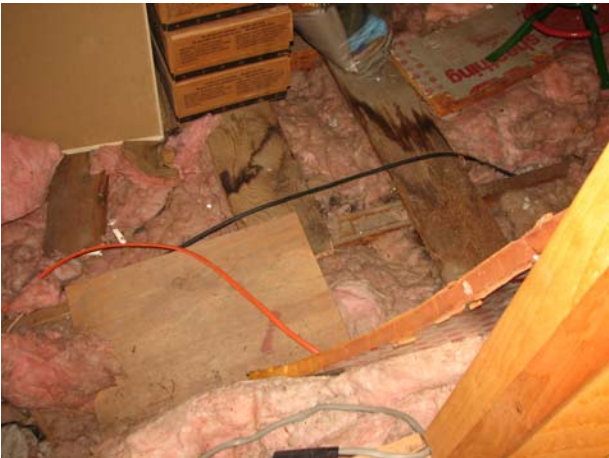
These very bright colors are hot wires, still the holes they go through in the ceiling could be sealed!

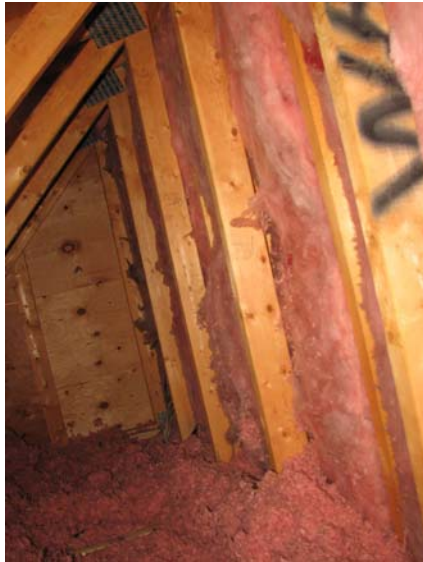
This is complicated to portray, but the meeting room is essentially suspended over the former roof and this truss system with minimal insulation. However, the access area is less than a foot so the most practical approach may be to seal off that area and air seal and insulate the perimeter.

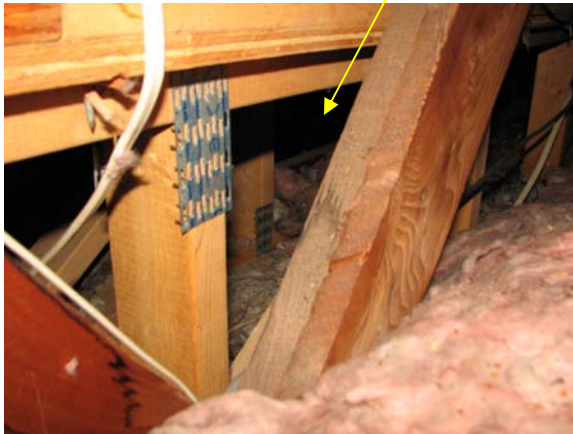
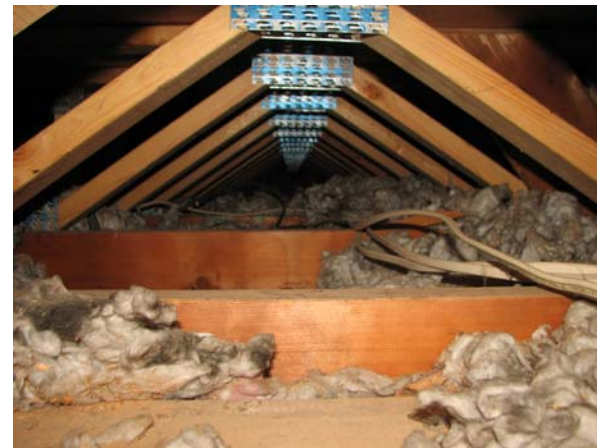
Heat loss through the concrete block walls is very high.

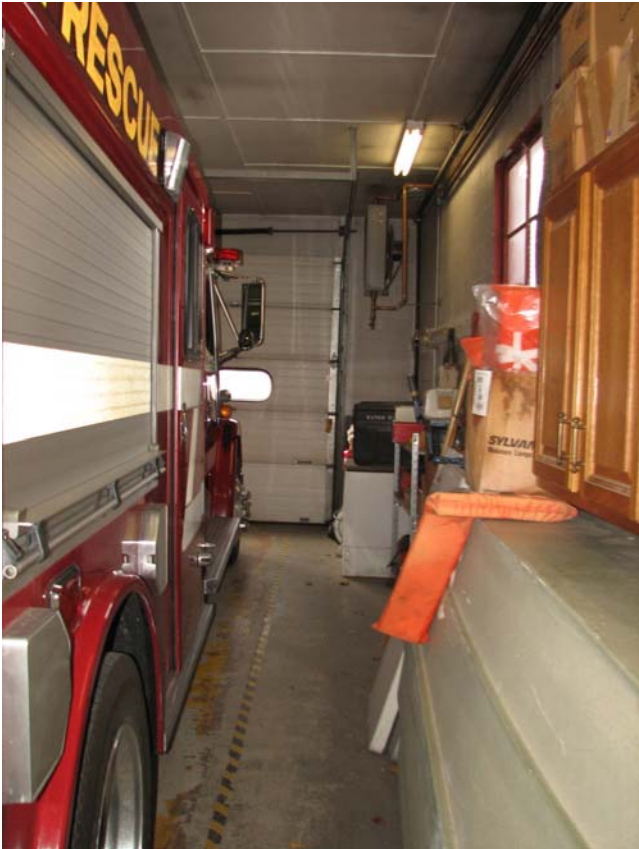
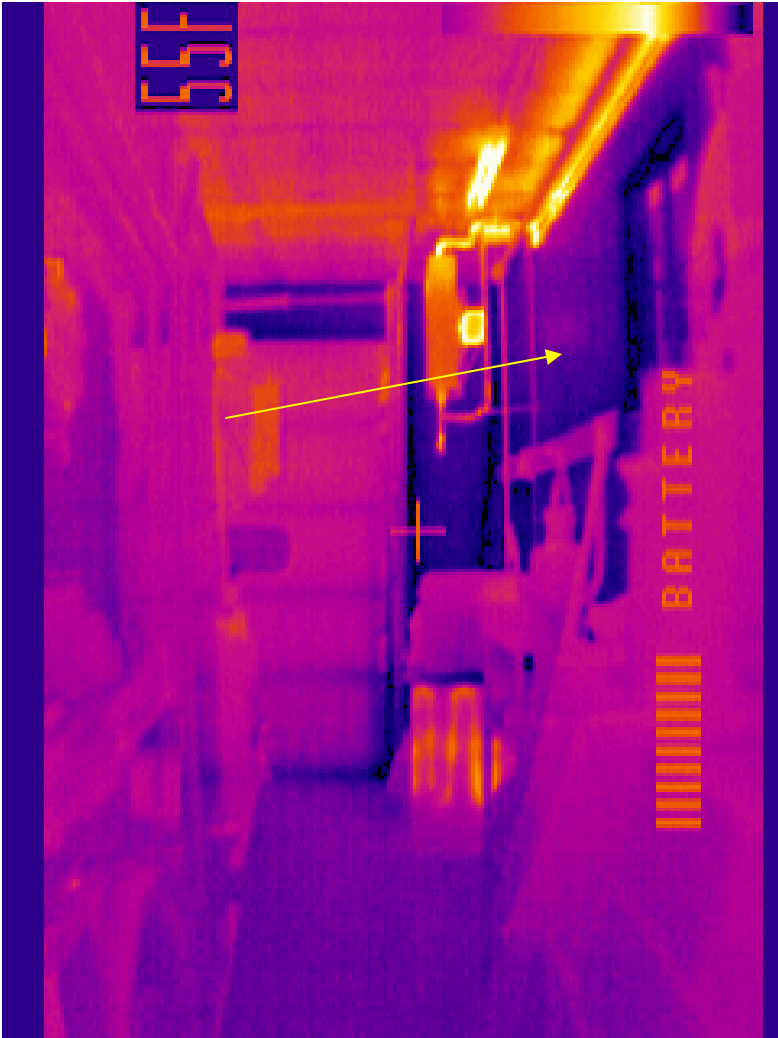
With deep overhangs, it would be fairly simple to adhere any one of a number of pre-finished insulated panels on the exterior of the building achieving R20 to R40. If there is a longer term commitment to the building, these upgrades, as well as proper ventilation of CO and moisture, with heat recovery, is recommended.

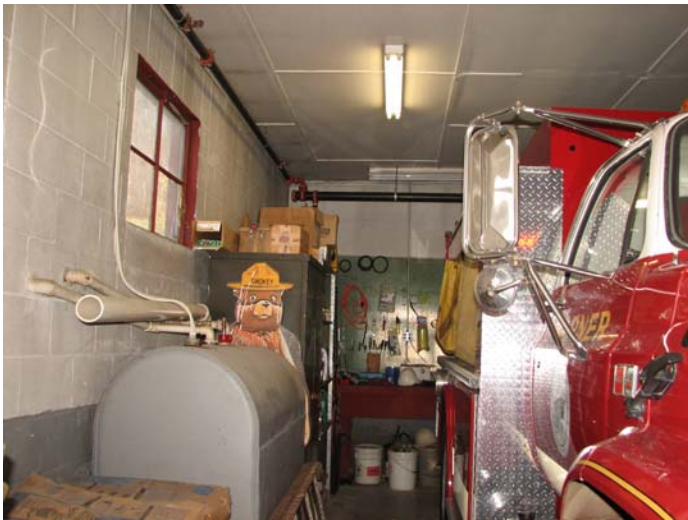
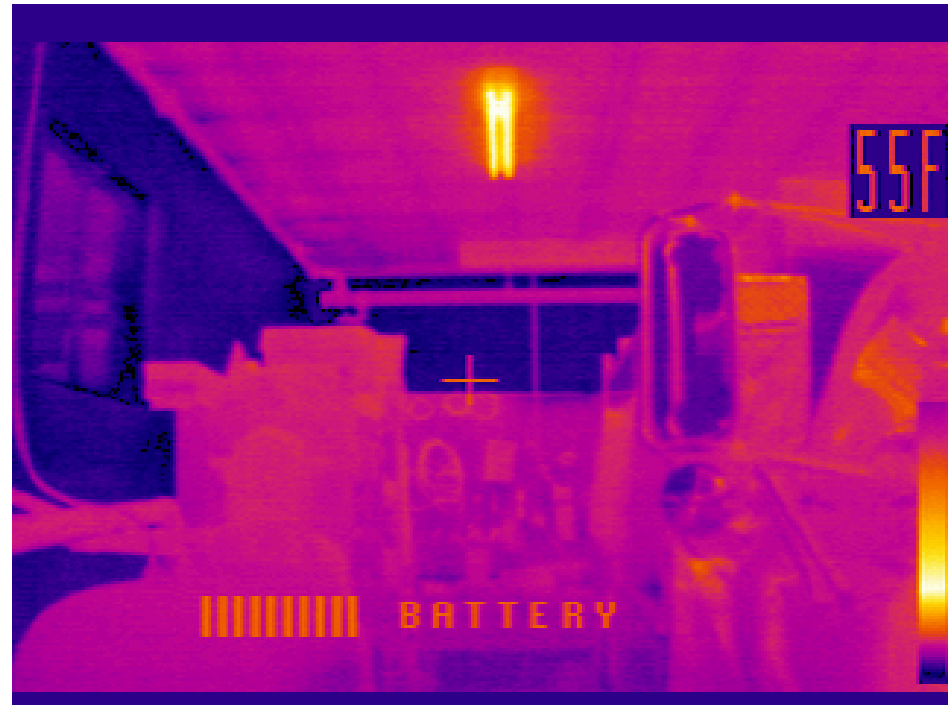
Remove AC unit in winter or at least cover with gasketed and insulated AC cover.

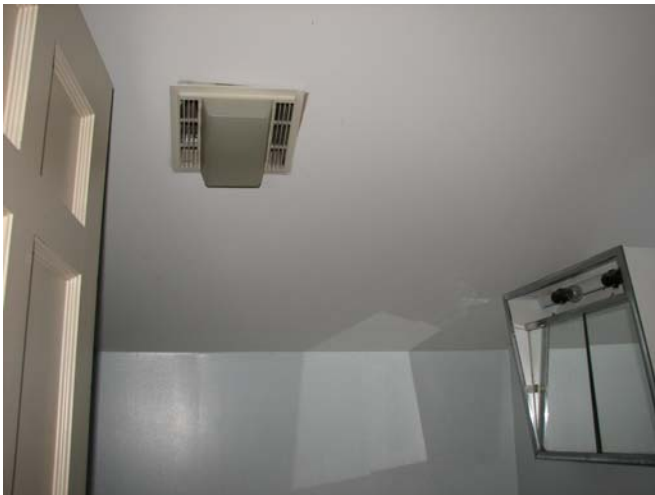
Even if moisture is not involved, these are areas of more significant heat loss.

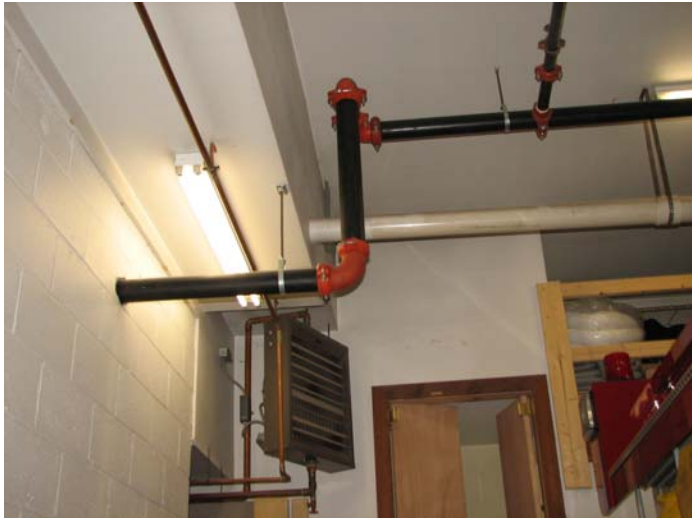
This appears to dry the hoses, however it seems that an exhaust fan at the top which had a tight seal when closed, would not only speed up drying but remove the moisture from the building more effectively and quickly.

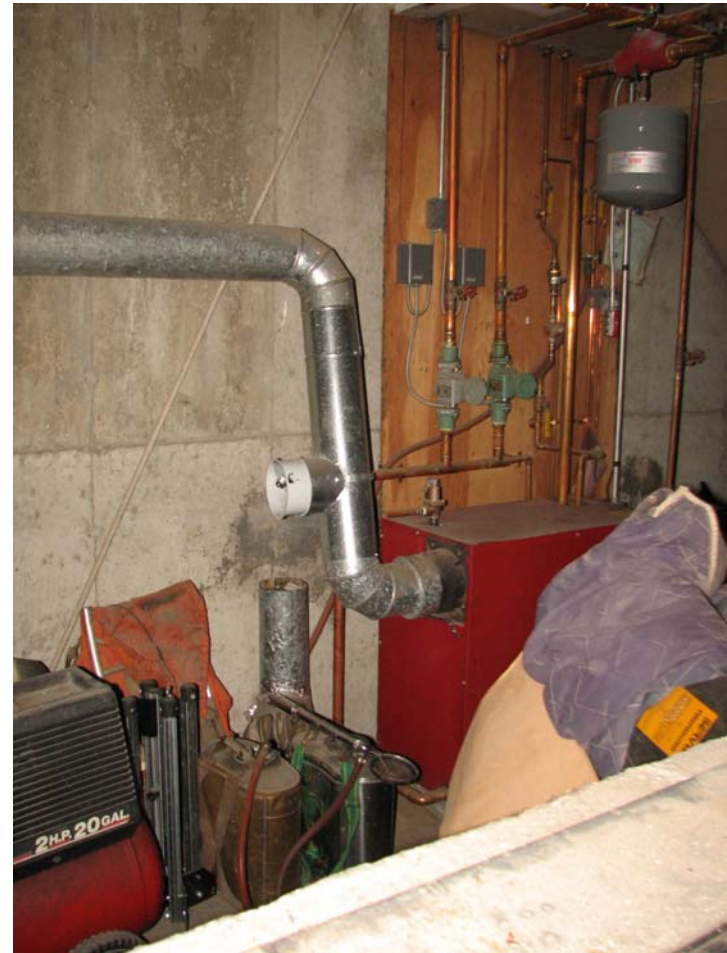
Hot water usage is minimal and so installing a tank less water heater, while more efficient, is not recommended at this time.

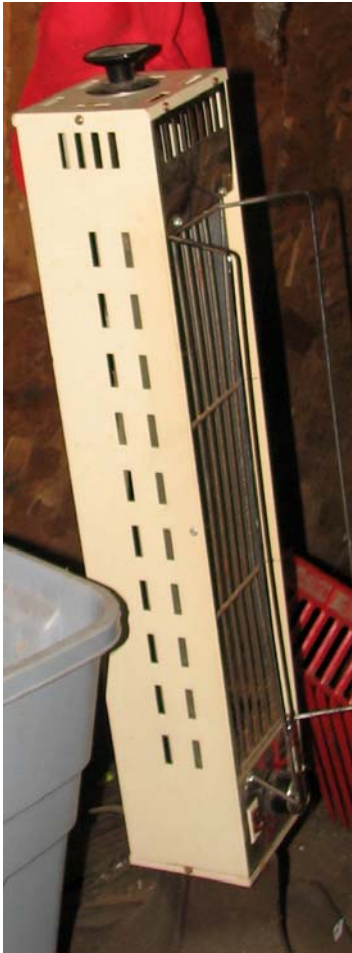
Without measuring the specific plug load, it is impossible to know how many KWH's are used for heating. Nor is it known how many gallons of used oil burned in this heater, nor how much greenhouse gas is emitted because of any of them. We can know, however, that these sources of heat matter, and reducing the heat loss of the building will save energy, money, and environmental impacts.

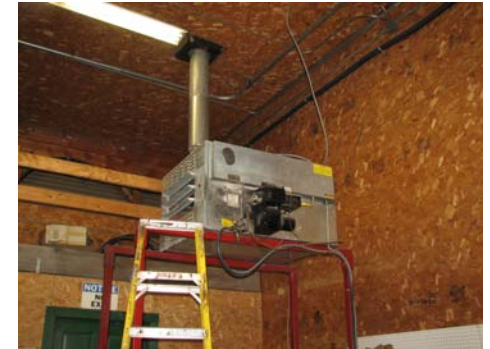
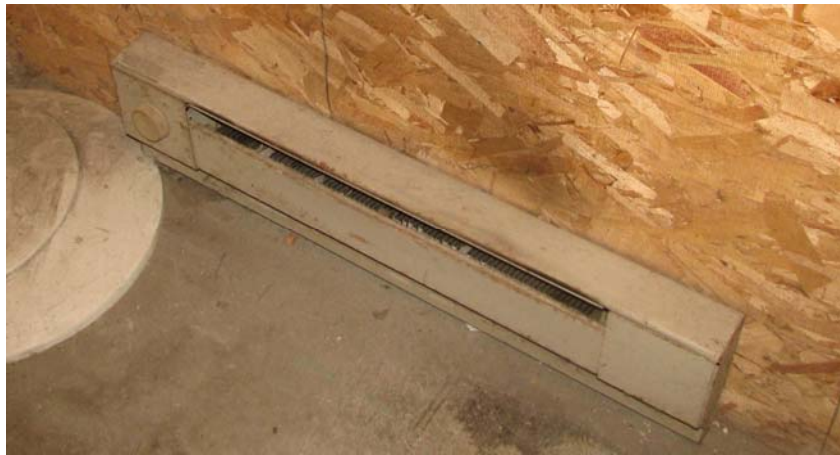
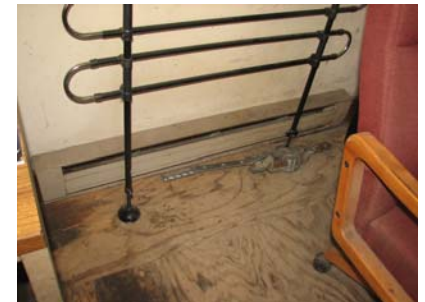
Distribution is of greater significance in this building as both hot air furnaces are located above 8 feet high and do not have duct work to blow the air to where the people are – so the ceiling is warm and the heavier cold air stays low. Installing ducts or a ceiling fan would help distribute the warm air but may not increase comfort unless the building were air sealed as much of the air being moved would be mixed with outdoor cold air.

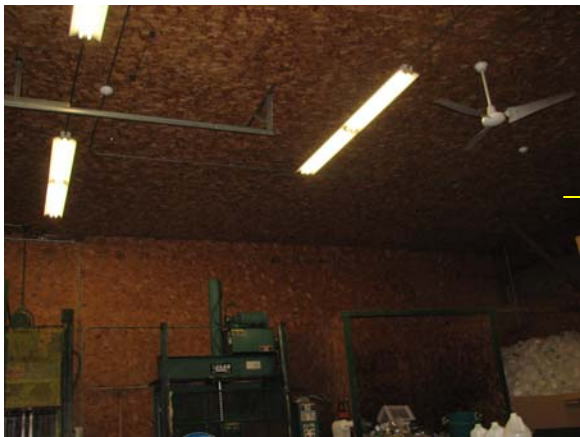
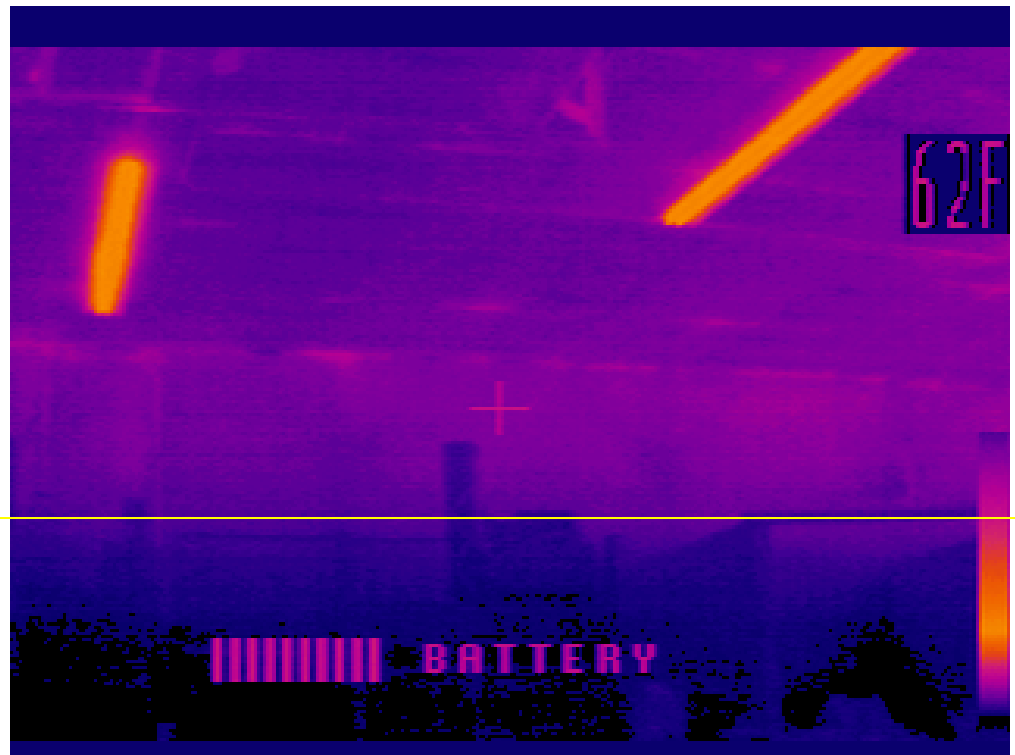
A blower door test was not conducted but IR clearly shows areas of air infiltration: doors, windows, seams in the wall and ceilings.

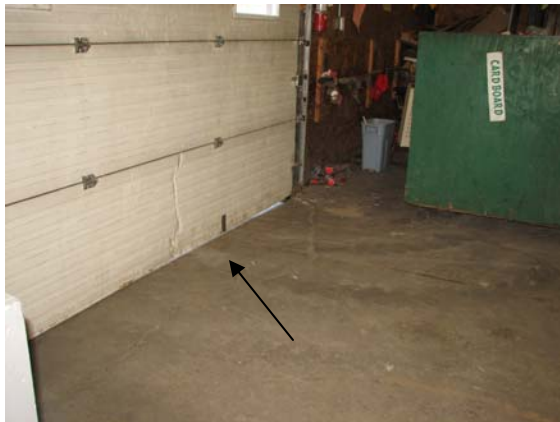
One of the largest sources of infiltration was a sliding door in the back of the building which led to the shed. During my site visit, several gentlemen came in to measure it with the intent of walling it in soon.

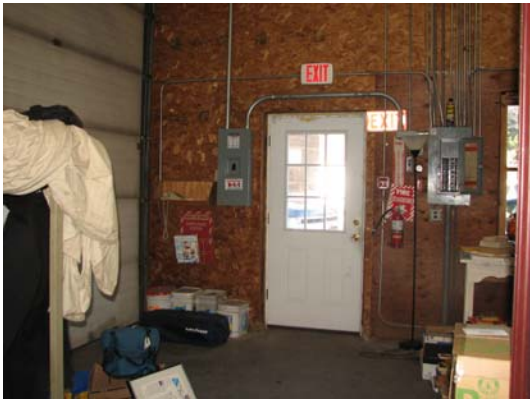
Glazing offers natural light but at the expense of heat loss.

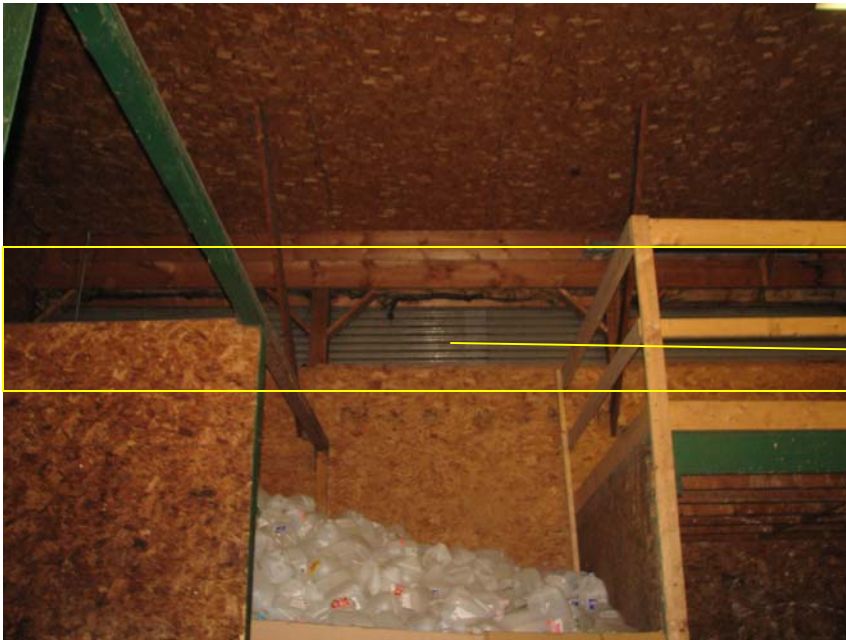
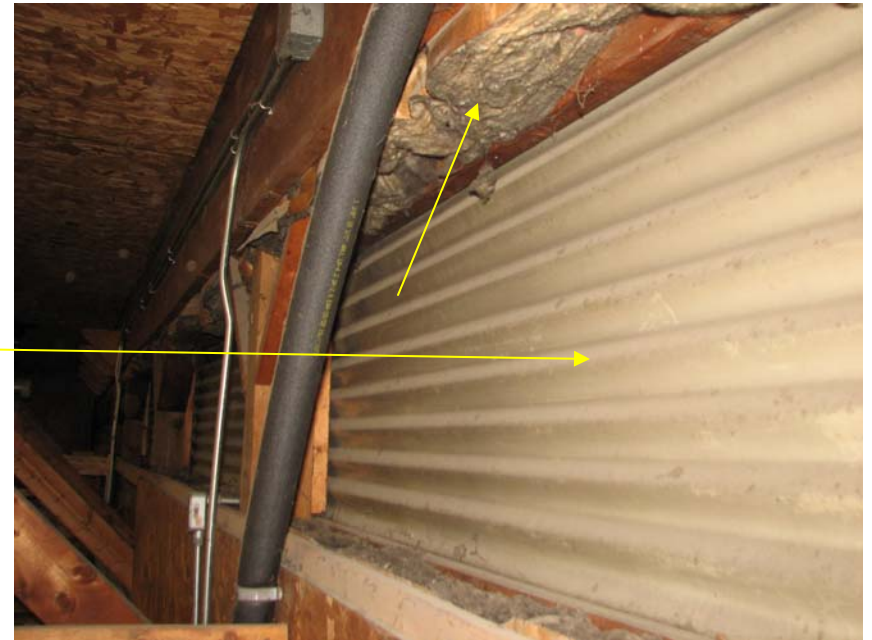
# Transfer Station Recommended Strategies
