# Town Garage

# ANNUAL ENERGY USE SUMMARY

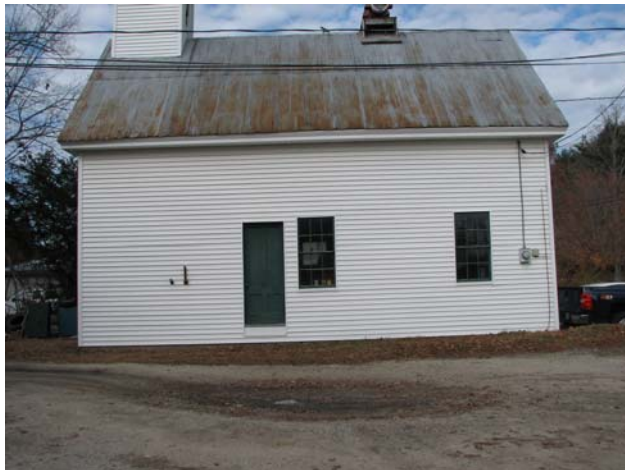
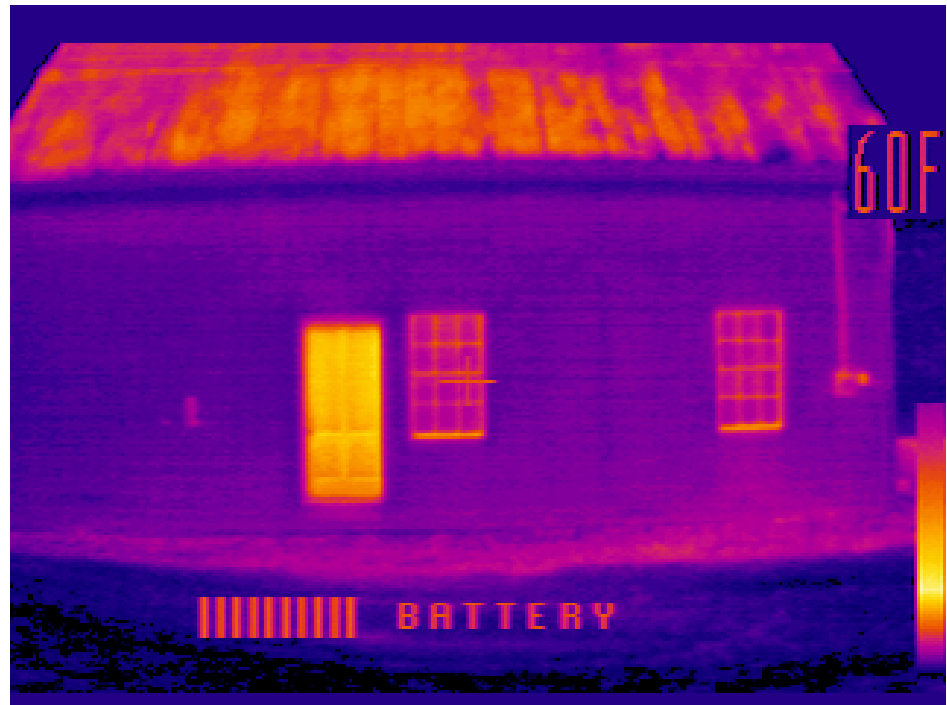
Air leakage thorough the old door, windows and garage door is significant, though there is also a tremendous amount of air leakage thorough the ceiling.

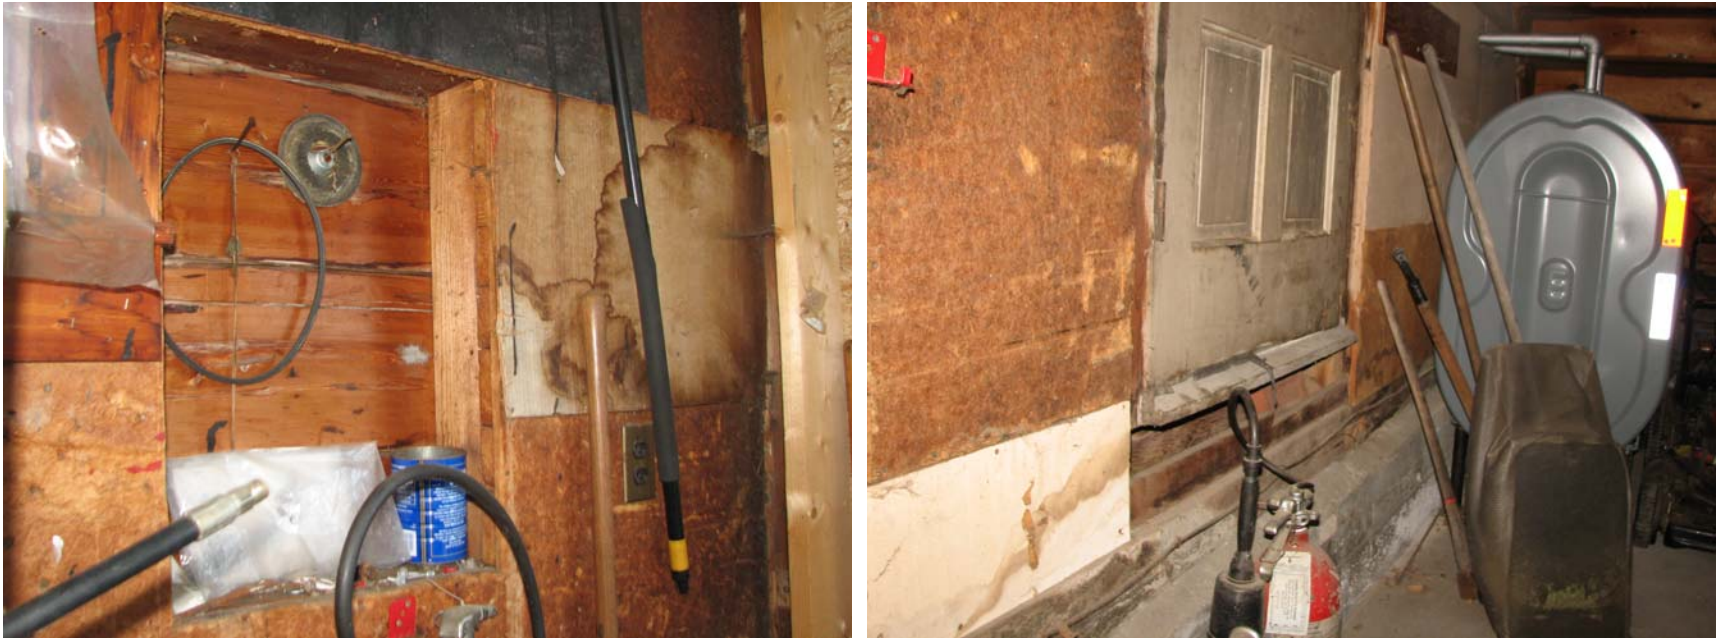
Just as with the newer fire station, the fuel consumption is relatively little and use of this building sporadic. However, its historic presence implies a greater level of commitment to the building. Therefore, while air sealing could reduce some of the heating costs cost effectively, a more comprehensive retrofit is recommended.

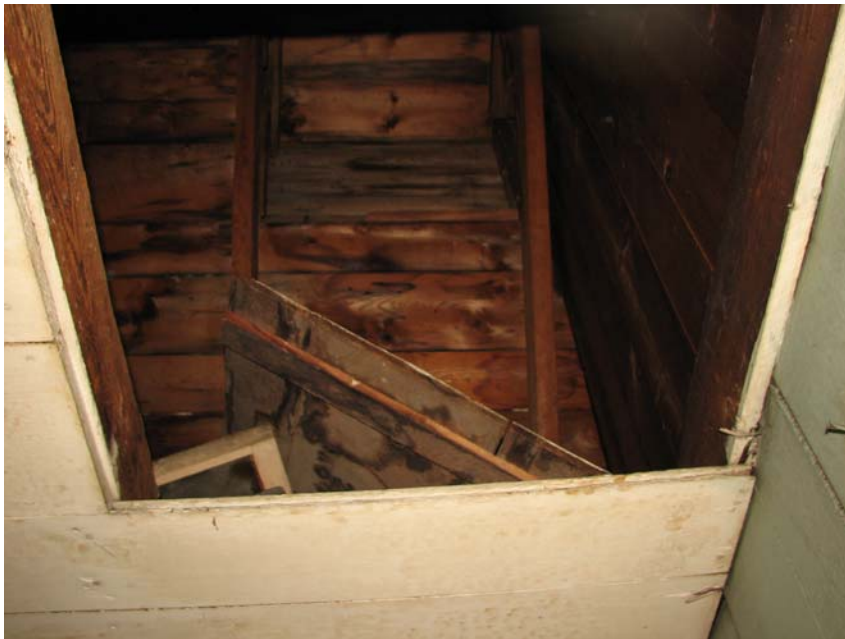
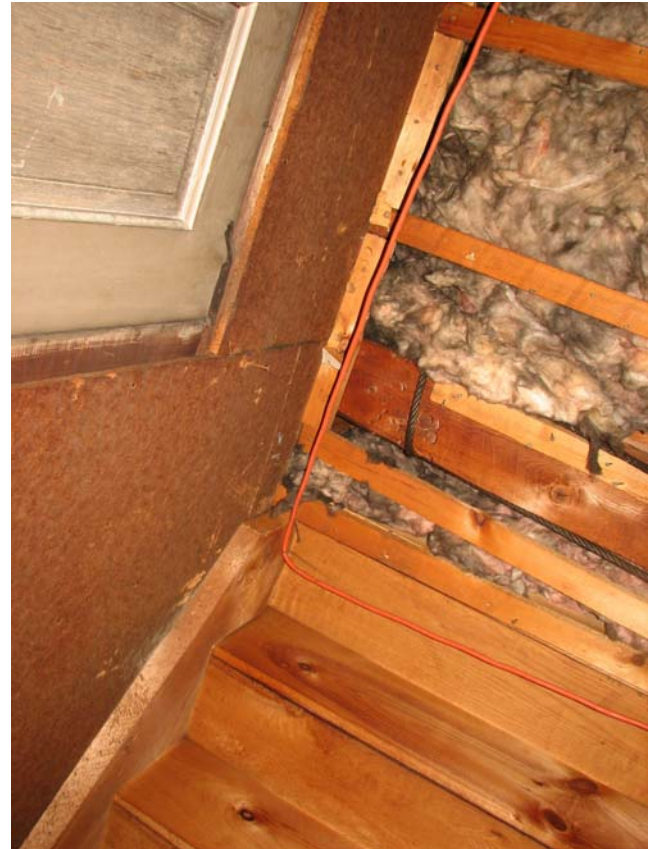
1. Best if fg batt in ceiling is also removed before installing the same 2" rigid foam board d on the ceiling strapping – strap again and apply drywall. Foam seal all perimeter connections.
2. Create a removable foam panel for side door and gasket into place.
3. Install interior thermopane storm windows on
4. Windows.
5. Gasket garage door.
6. Install programmable thermostat and set to 40 degrees. The furnace will come on very little if at all, all winter.

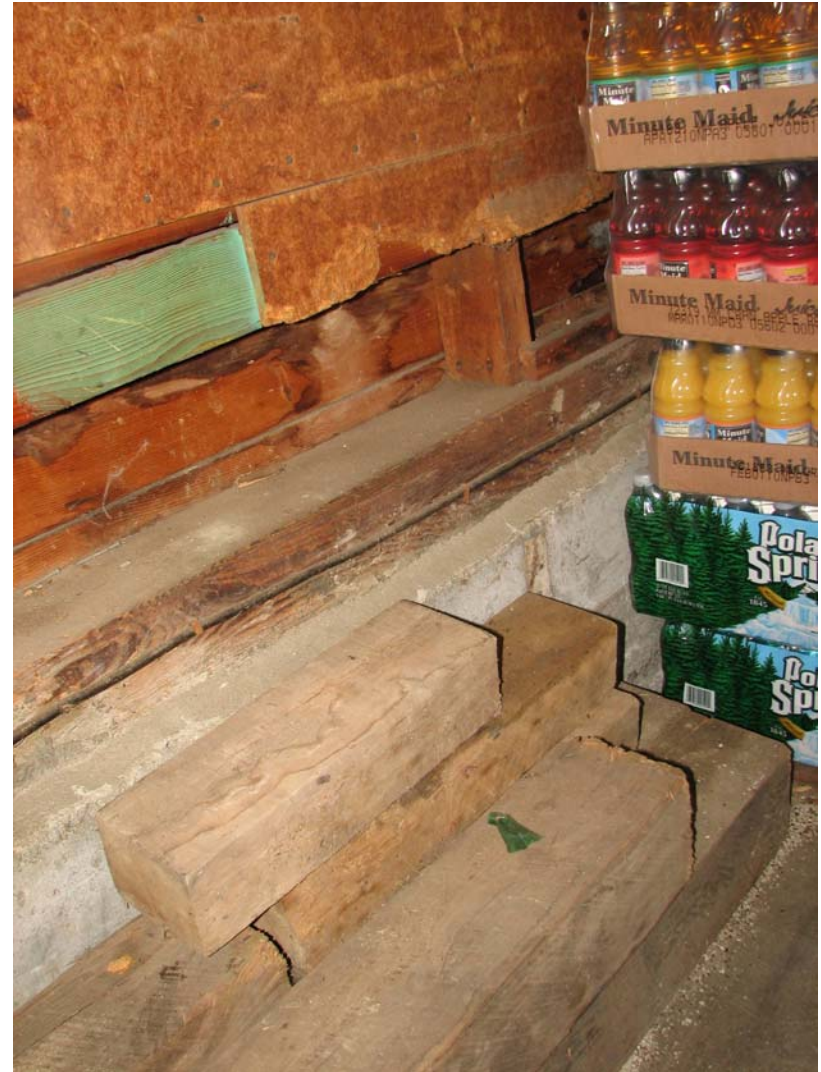
While this furnace is not efficient, it does serve the purpose until the new loads can be calculated, at which time a cleaner and more efficient solution can be found. Using about 150 gallons does limit the cost/benefit approach to energy upgrades.

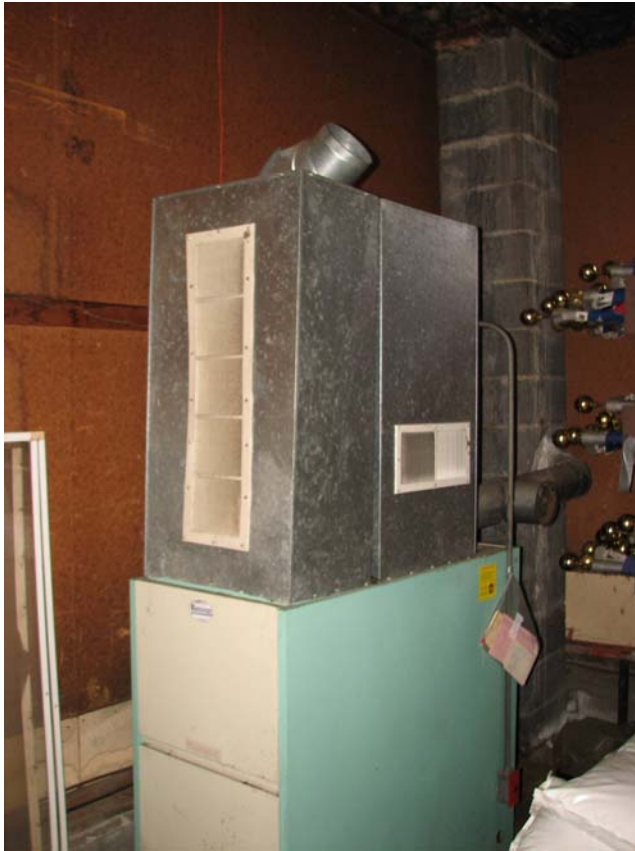
For professional insulation and air sealing, I recommend calling Don LaTourette and Andy Duncan of Building Energy Technologies in Concord. 724-7849.
